Fatigue Behavior and Failure Mechanisms
of Centrally Notched [0]₂ and [(0/90)₂]₅
Silicon Carbide Reinforced
Aluminosilicate Glass

THESIS

William R. Moschelle
Captain, USAF
AFIT/GAE/ENY/91D-19

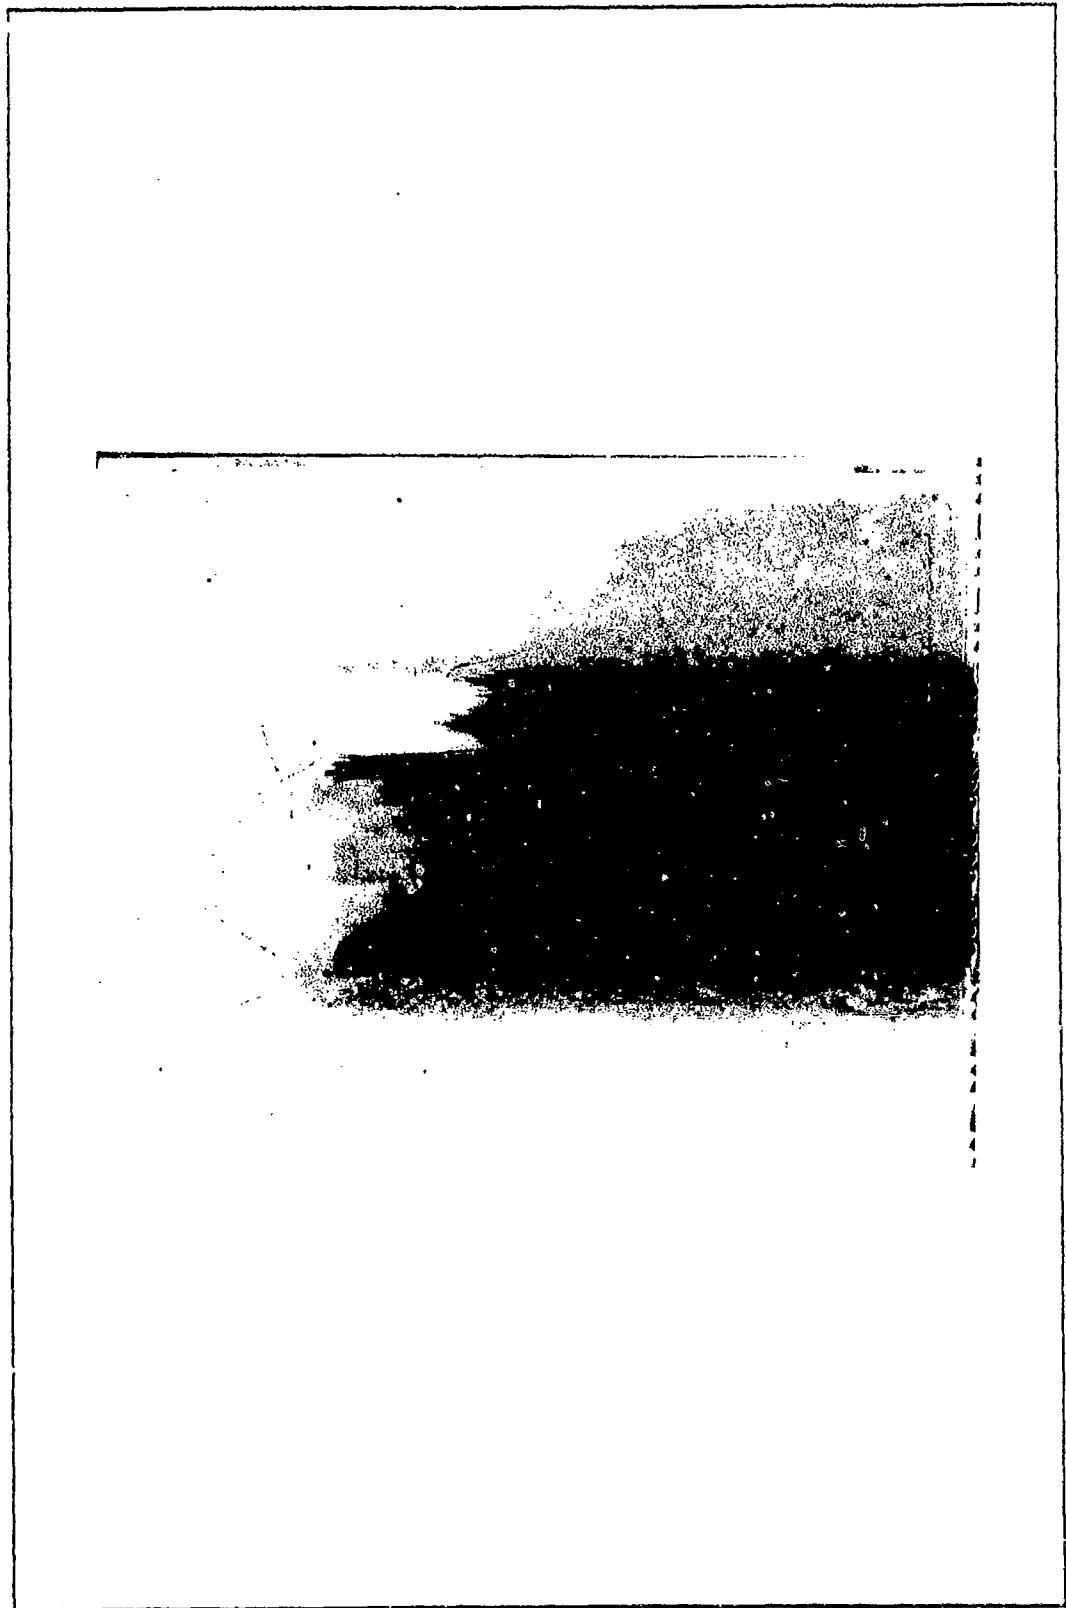
A macroscopic view of the fracture surface is shown in figures 62 and 63. Figure 62 depicts the fracture across the width of the specimen. The final fracture is across the hole. This correlates with the high crack density that was shown in figure 58. A side view of the same fracture is given in figure 63. Delaminations can be clearly seen here.

Figure 62 Fracture Surface, Across Width
209 MPa Test, 6.3X Magnification

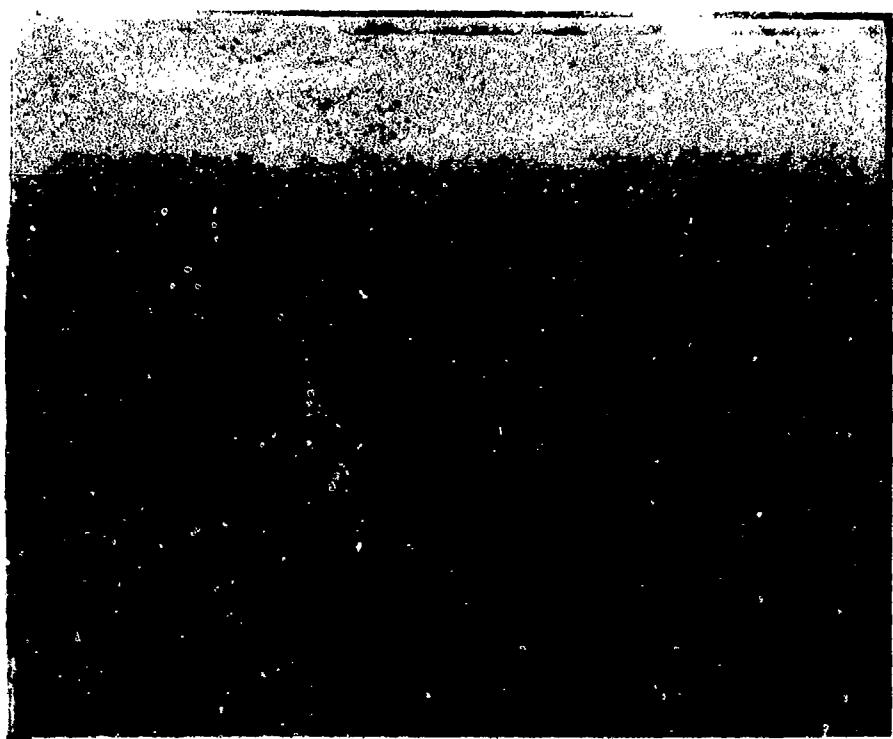
Figure 63 Fracture Surface, Side View
209 MPa Test, 6.3X Magnification

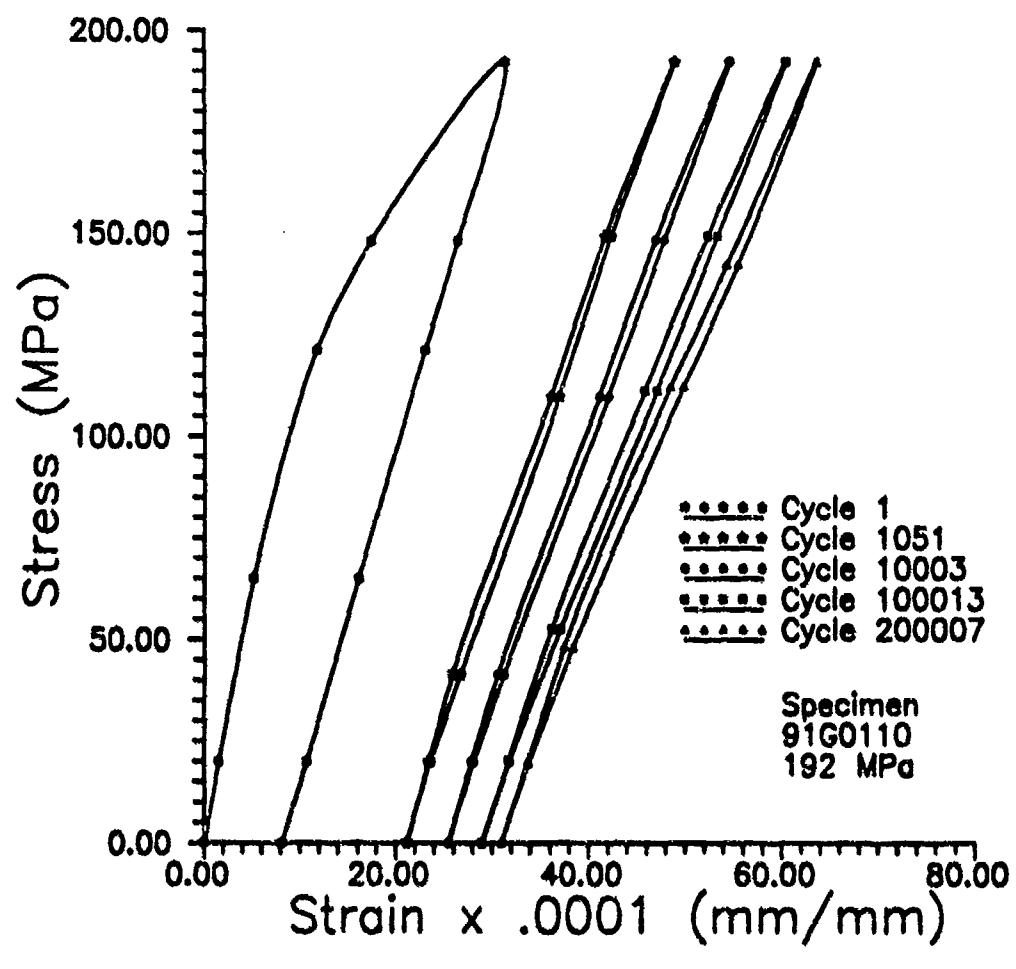
Figure 64 Stress Vs. Strain 192 MPa Test

The stress-strain results of figure 64 show trends that are almost identical to the 209 MPa test.. This test also showed large amounts of residual strain early in the test. Final strain appeared to be larger than that in the 209 MPa test. However, data collection did not occur between 50000 and 87587 cycles in the 209 MPa test due to the logarithmic nature of the collection. Therefore, the actual final residual strain in the 209 MPa test was not computed.

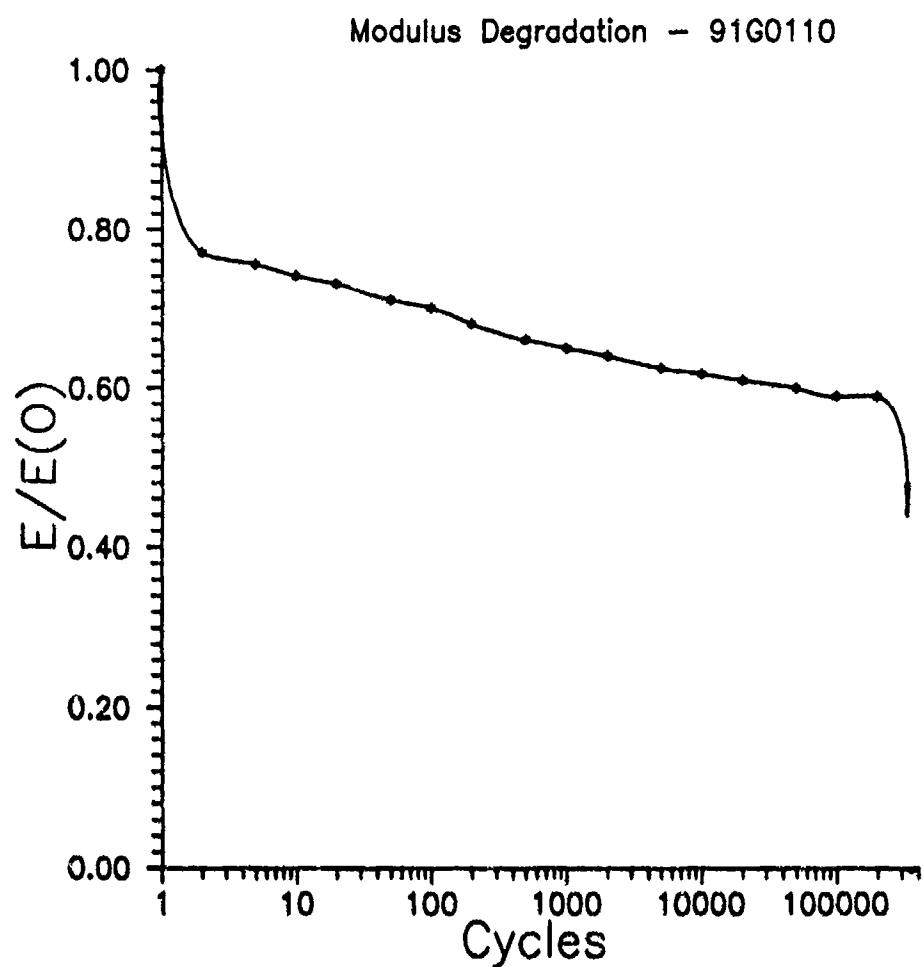
Figure 65 Modulus Reduction 192 MPa Test

The 192 MPa test shows steady decrease in stiffness throughout the test. The matrix crack closure level is again in the 40 MPa range. The steady degradation of stiffness is confirmed in figure 65. There is a sharp decrease in the first few cycles due to the establishment of transverse matrix cracks in the 90° plies. The steady decrease thereafter can be attributed to crack propagation and coupling at the ply boundaries leading to delamination. This specimen failed at 357881 cycles.

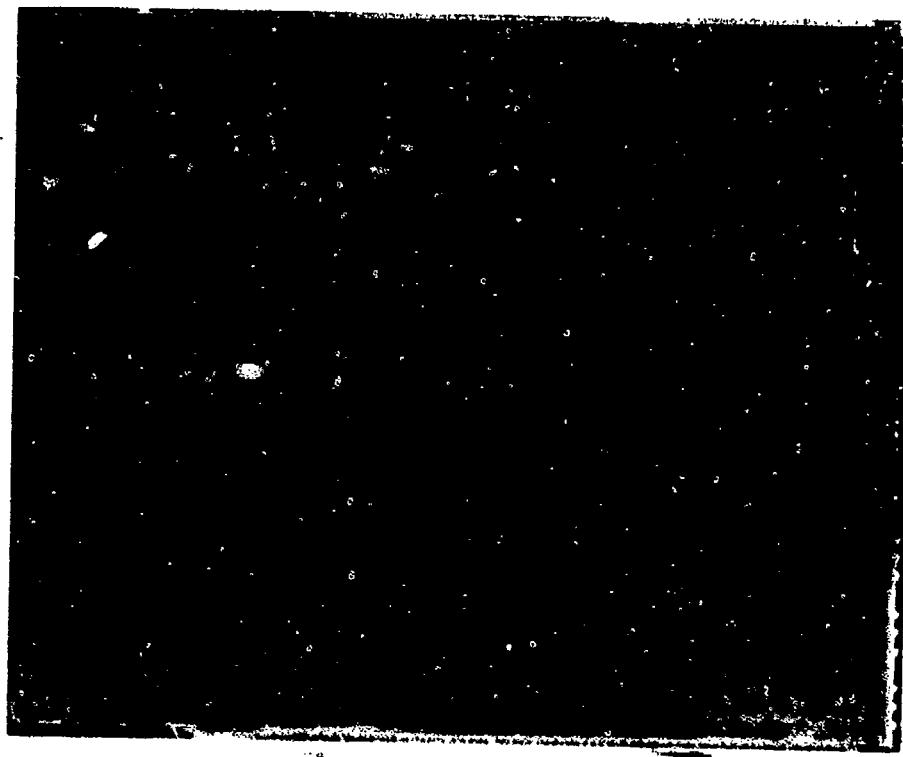
Figure 68 Final Fracture, Specimen 91G0108

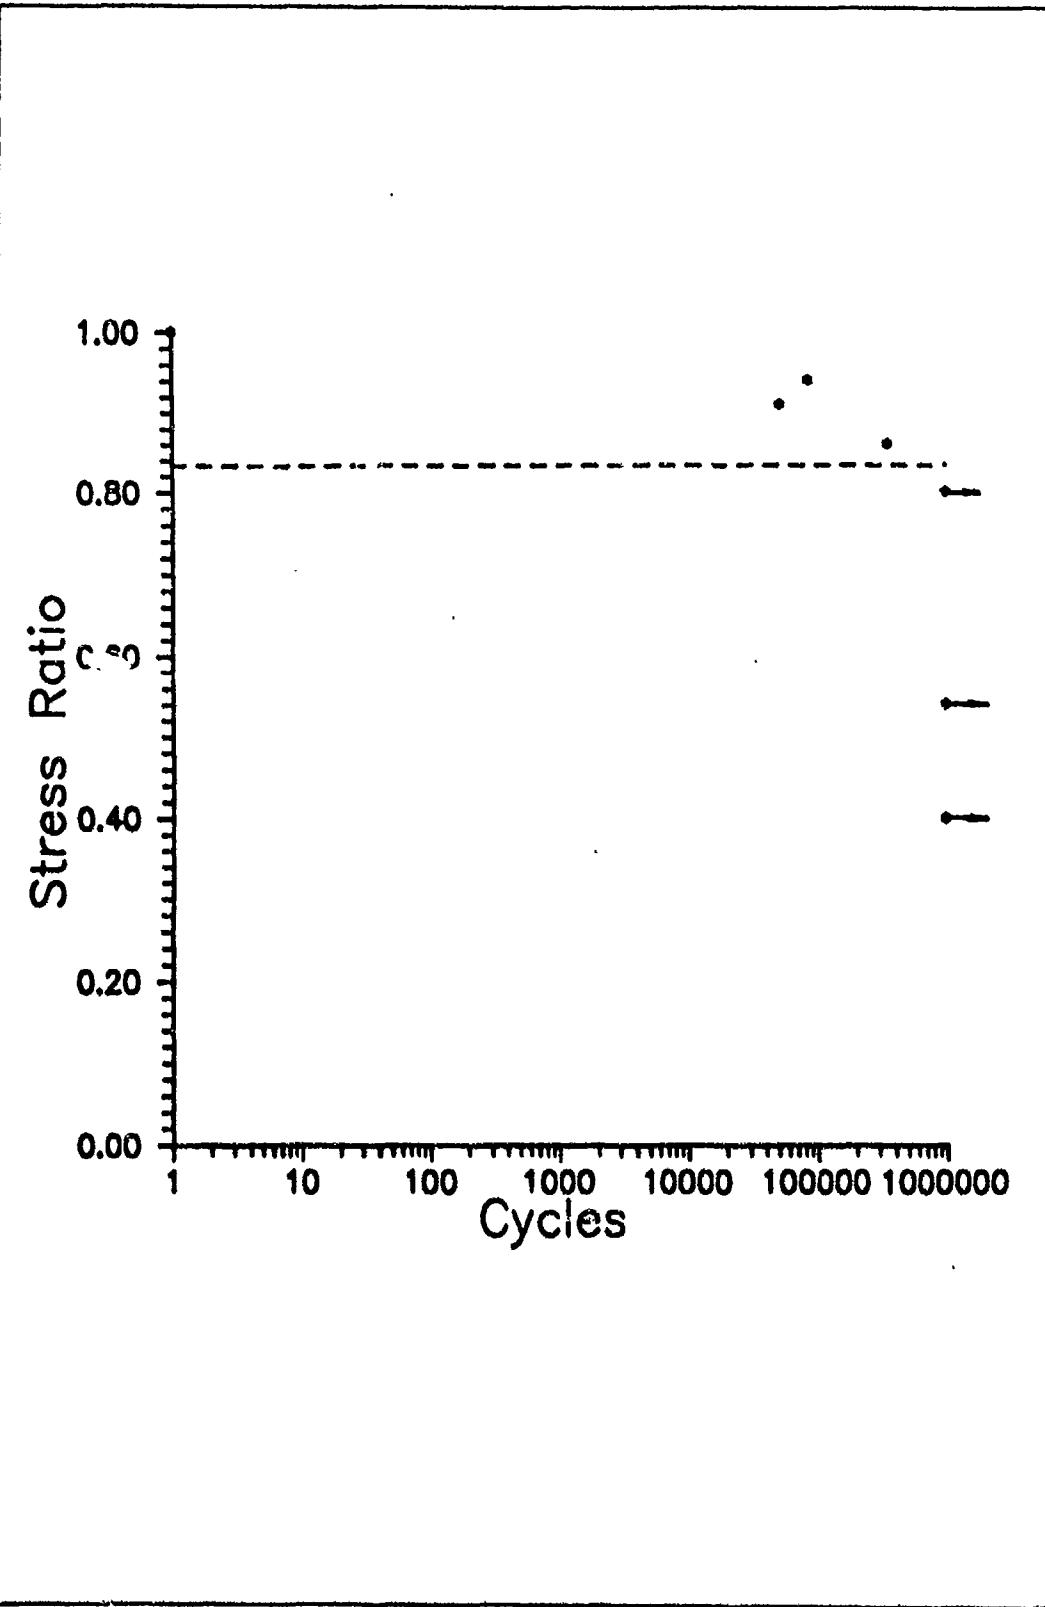
Figure 69 S-N Curve $[(0/90)_2]_s$ Laminates

Even though this specimen did not last as long as the 209 MPa test, it is within the scatter band normally seen in composite fatigue testing. Therefore, the test was considered a valid data point. The final S-N curve is presented in figure 69. The dashed horizontal line depicts the endurance limit for the bidirectional laminate.

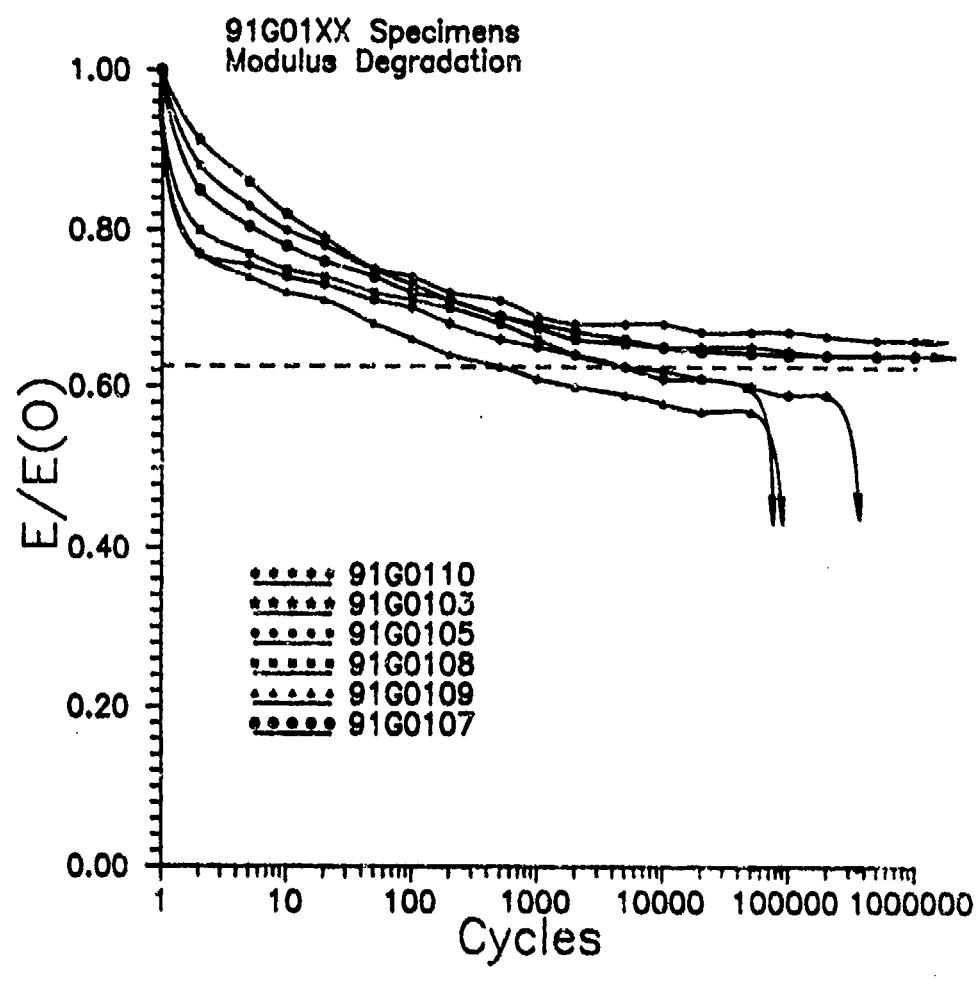
Figure 70 Modulus Degradation $[(0/90)_s]$, Specimens

Total ply failure was assumed in the transverse plies, thus, $[\bar{Q}_{ij}]$ values were set to zero for those laminae. The extensional stiffnesses were then recomputed leading to a longitudinal modulus of 70.99 GPa. This represented .61 of the original modulus value. This value is shown as the dashed horizontal line in figure 70, which depicts the modulus degradation for all bidirectional tests. The line marks the point between fatigue failure and run-out. Assuming total ply failure in the 90° plies is consistent with the damage modes that were observed. Transverse cracking extended in the 90° plies leading to fracture and delamination with the 0° lamina. The 0° laminae were then bearing the entire load leading to fiber fracture and
